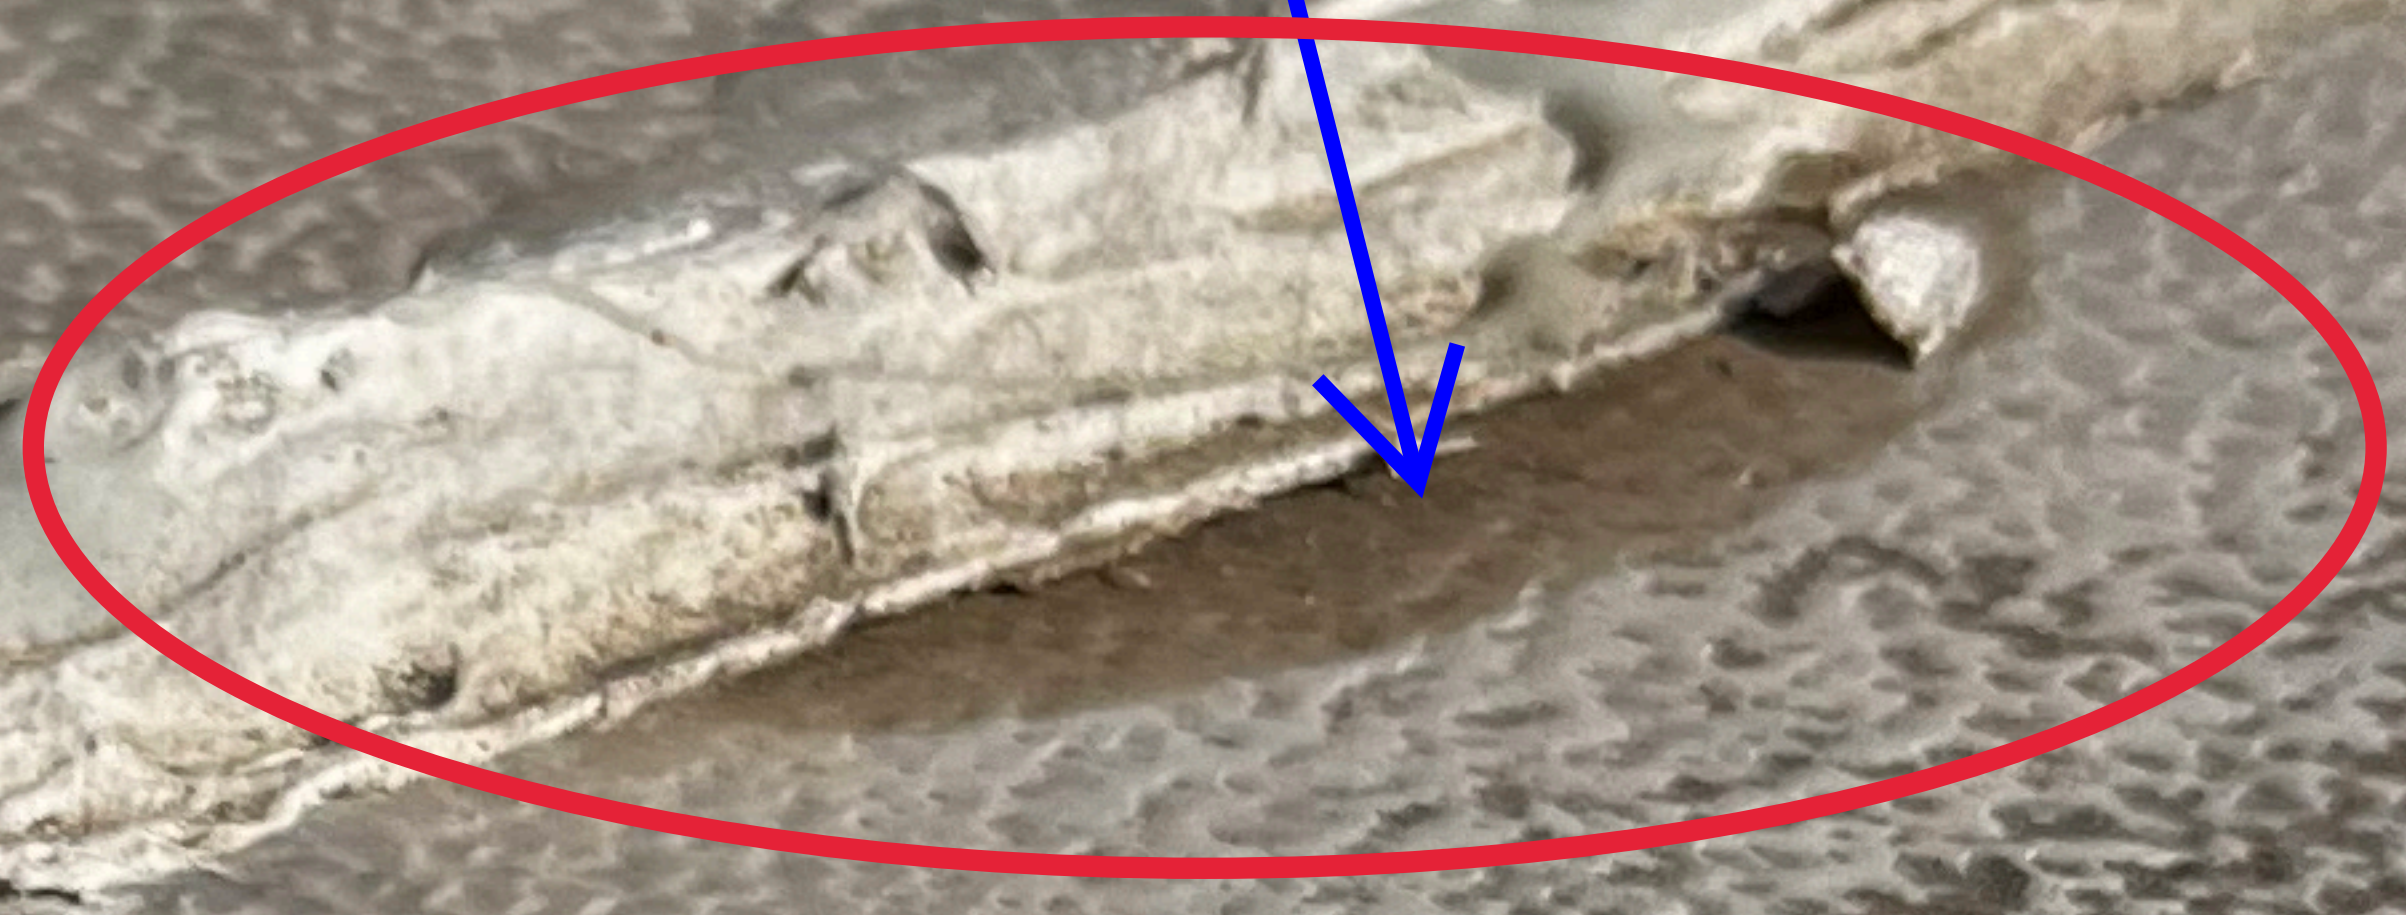
This is where I think the water is getting in. Water pools on top of this vent and then slowly drains into this small gap.

This is where the water will pool during a rain. The vent top is not sufficiently angled to shed water. It will pool and then seep into the small crack noted at the left (which is now

This is the first layer of Vulkem caulk. Vent material was damp so adhesion may not be ideal. Tried forcing as much caulk into crack area as possible.

This is the second layer of latex caulk. Vent material was damp so adhesion may not be ideal. Tried forcing as much caulk into crack area as possible

Another view of my caulk mess. Here I am trying to dam up the water to keep it from seeping into the crack. Will probably need to redo this when the weather gets warmer.
